MITCHELL LAKE DAM  
DENT COUNTY, MISSOURI  
MO 38268

# **PHASE 1 INSPECTION REPORT NATIONAL DAM SAFETY PROGRAM**

PHASE I INSPECTION REPORT  
NATIONAL DAM SAFETY PROGRAM

Name of Dam:	Mitchell Lake Dam
State Located:	Missouri
County Located:	Dent
Stream:	Unnamed Tributary of Meramec River
Date of Inspection:	August 15, 1979

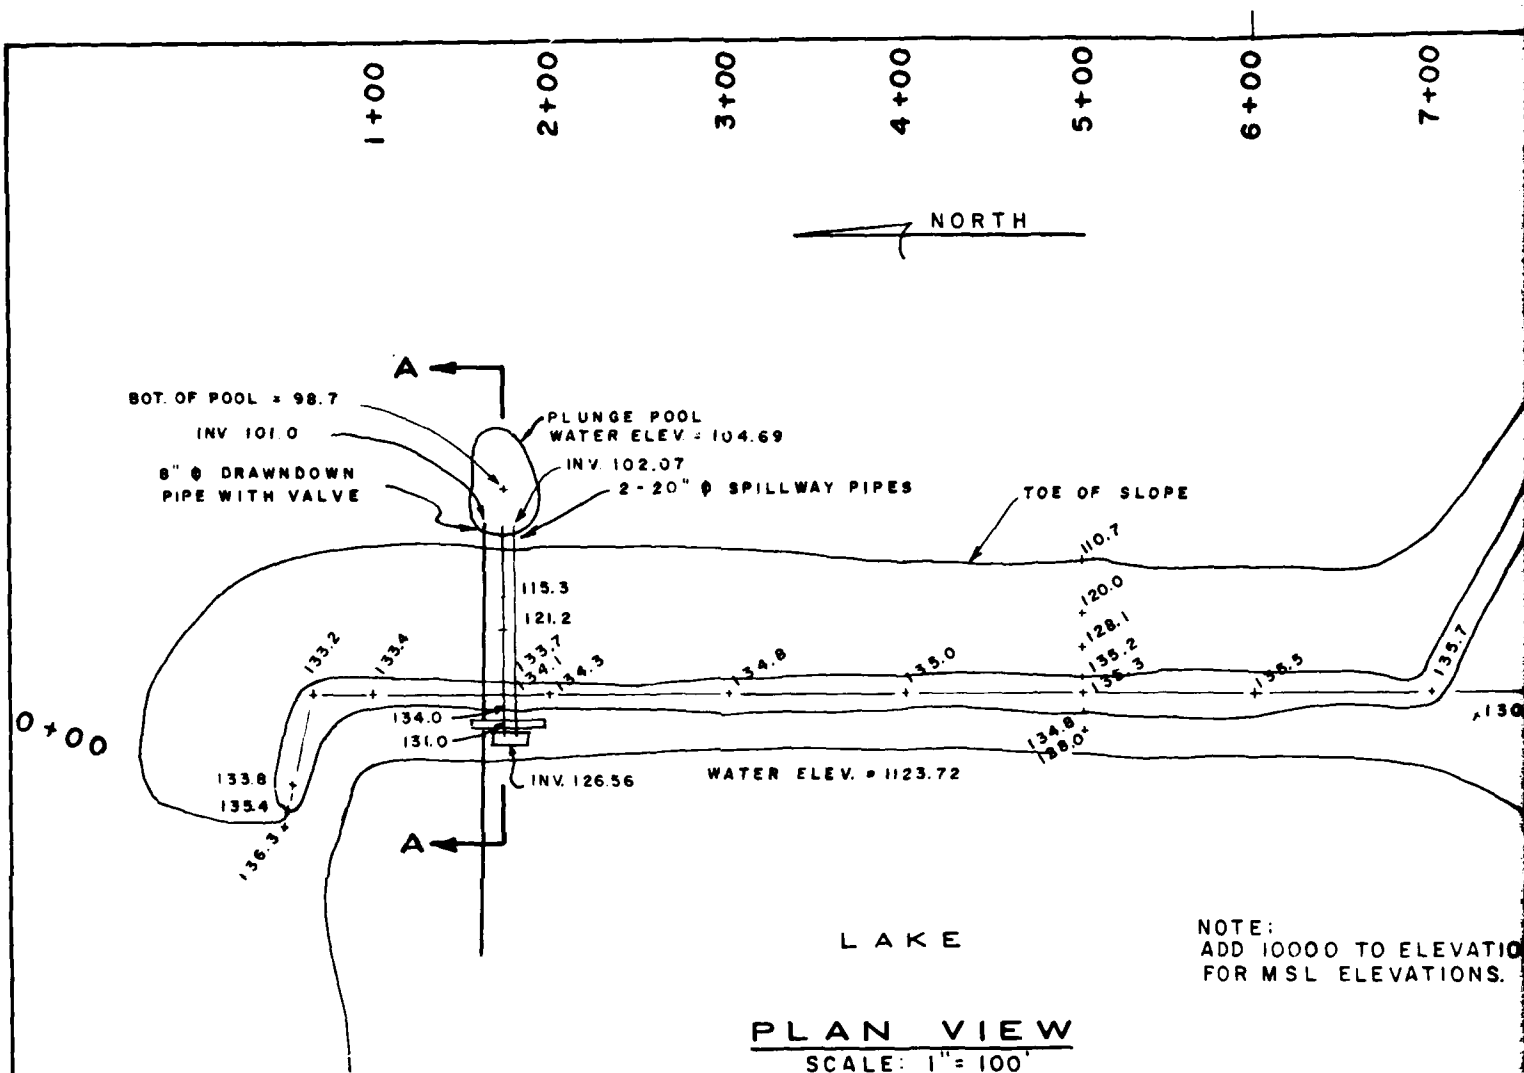
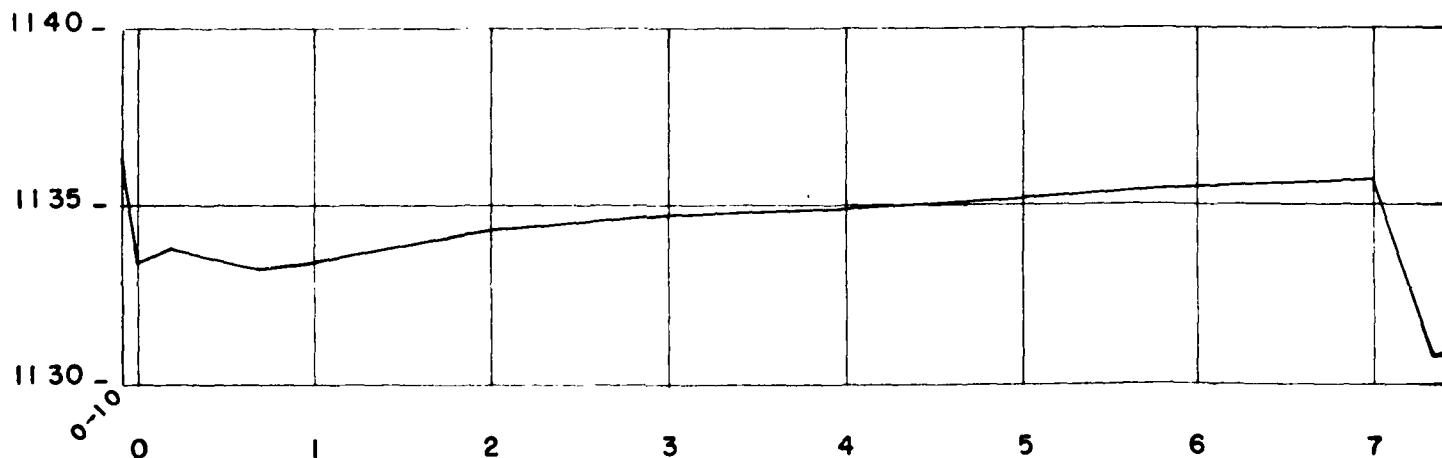
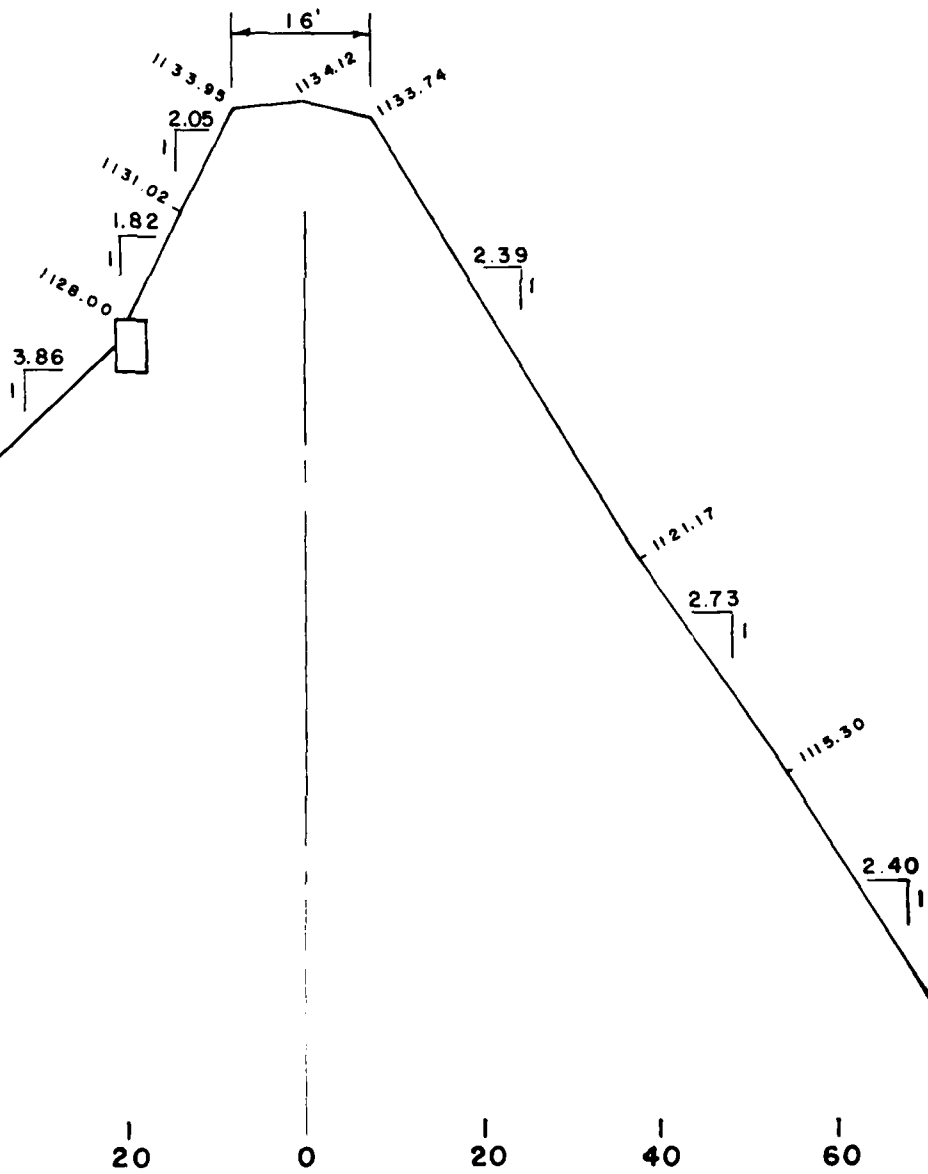
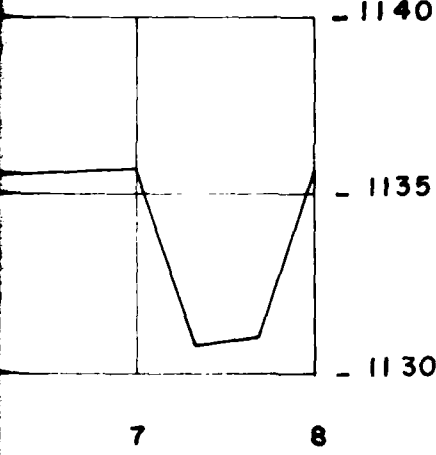
SHEET 3 OF 4

The crest of the dam slopes downward to the north (see Sheet 3, Appendix A). This sloping results in about a 3 ft difference in crest elevation across its length. The horizontal alignment of the embankment is good. No surface cracks or unusual movements were noted. Some small brush growth was present on the embankment face. The owner reported that the dam is not mowed.
